## **EVALUATION OF FIRE ON THERMAL OXIDIZER (TOX) AT XY COMPANY WITH FISHBONE APPROACH**

### **Abstract**

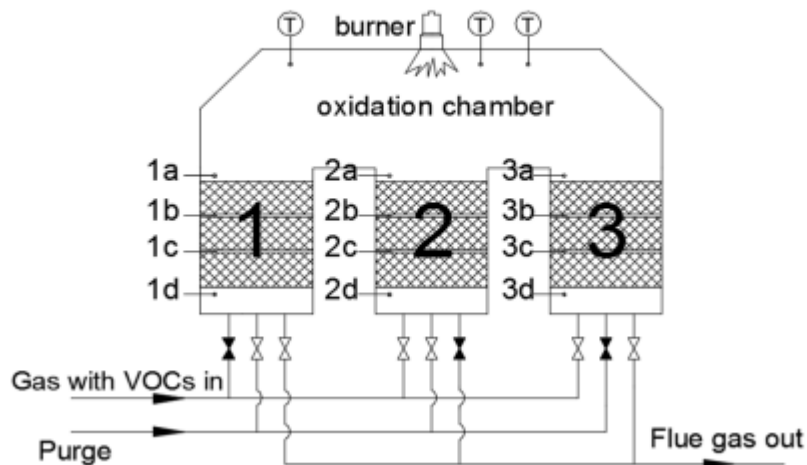
#### TOX Images

The condition of TOX burning at PT. The current XY is very different from the original design of TOX; the input numbers are very different, and the combustion temperature is very high, over 1,600°F (1,144 K). In addition, the WHRU does not work normally, so the stack output temperature is still very high, over 700°F (644 K), and the hot oil temperature at the WHRU outlet is only 330–340°F (438–444 K).

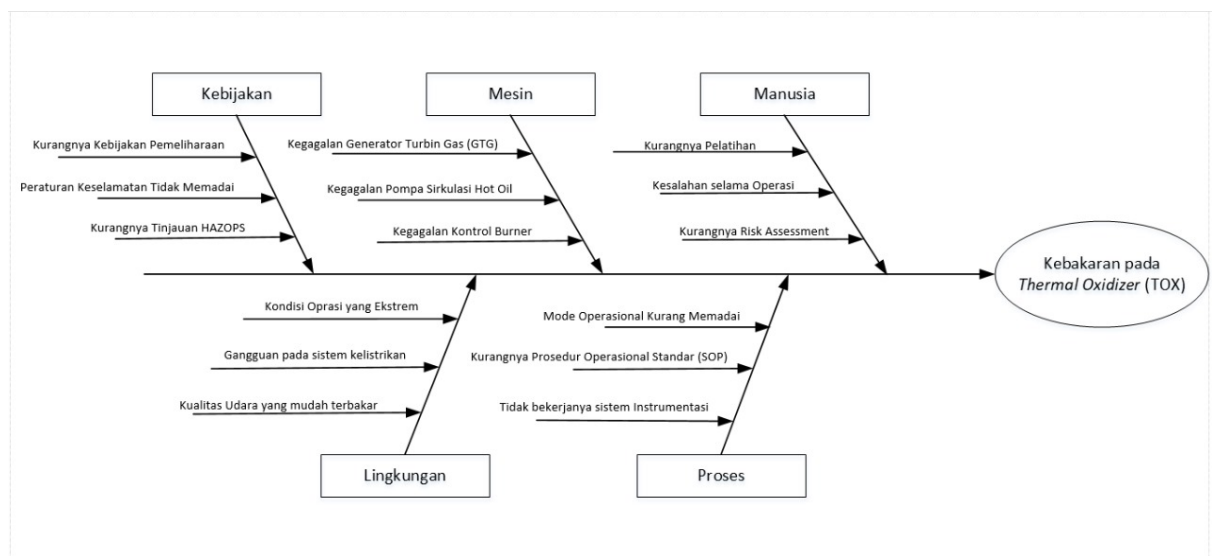
Figure 1

Based on Figure 1, the identification of the factors causing the TOX Fire at PT. XY. The following is an explanation of the factors that cause accidents from each category in the fishbone diagram above, which includes humans, processes, environment, policies and machines:

Lack of maintenance policies, inadequate safety regulations, and incomplete HAZOPS reviews have led to vulnerable machine components to damage (Anggraini Agustini, 2022). In addition, failure of gas turbine generators (GTGs), hot oil circulation pumps, and burner controls can increase the risk of fire. Human factors such as lack of

training, errors during operations, and lack of risk assessment also contribute to fire incidents. Extreme operating conditions, disruptions to the electrical system, and flammable air quality exacerbate the situation. The lack of standard operating procedures (SOPs) and the non-functioning of the instrumentation system can exacerbate the problem.

Failure of the gas turbine generator (GTG), hot oil circulation pump, and burner control can contribute to system malfunctions that can potentially trigger a fire. When GTG fails, the power supply to critical equipment can be disrupted, resulting in the system not functioning properly. In addition, if the hot oil circulation pump is not operating optimally, the flow of hot oil required to maintain the temperature and pressure of the system becomes inadequate, increasing the risk of overheating. On the other hand, burner controls that don't work properly can cause the burner to stay on even if the surrounding conditions are unsafe, creating a very dangerous situation

The lack of training for operators contributes to a lack of knowledge and skills in operating equipment safely. This can lead to errors during surgery, which is often caused by a lack of concentration and awareness of the risks involved. In addition, inadequacy in conducting risk assessments indicates weak identification of potential hazards and lack of effective countermeasures, thereby increasing the likelihood of dangerous incidents (Dhimas Pravi Ghossan Soesanto, n.d.).

Extreme operating conditions, such as high temperatures or humidity, can significantly increase the potential risk of fire. Disturbances in the electrical system also have the potential to cause short circuits, which can trigger fires. In addition, the quality of air containing flammable materials increases the risk of fire, especially in the event of sparks or combustion processes. The combination of these factors creates a very dangerous environment and requires special attention in safety management.

Inadequate operational modes reflect deficiencies in proper operational standards and procedures. In the absence of clear standard operating procedures (SOPs), operators do not have adequate guidance for operating machines safely, increasing the risk of errors. Additionally, malfunctioning instrumentation systems result in a lack of early detection of potential hazards, which can worsen the situation in the event of an incident. Therefore, it is important to strengthen operational standards and ensure that instrumentation systems are functioning properly to improve safety in the workplace.

Fire at *Thermal Oxidizer* (TOX) at PT. XY on April 9, 2020 was caused by the failure of the hot oil circulation pump system and its *Gas Turbine Generators* (GTG), which caused overheating of the coil tubes in the *Waste Heat Recovery Unit* (WHRU), as well as burner control problems without an effective shutdown interlock. The lack of risk assessment and maintenance of the instrumentation system also contributes, coupled with uncontrolled environmental factors. These findings emphasize the need for an evaluation of safety management systems and improved procedures to prevent similar incidents in the future.

To prevent similar fires at PT. XY, it is necessary to carry out equipment re-inspection, HAZOPS upgrade for hot oil system, and in-depth inspection of *hot oil coil tubes*. In addition, analysis of affected equipment failures, determination of the cause of "trip" in GTG, and improvement of operational procedures and worker skills in process safety are also essential.
